OTR Rim Certification, Inc.

Onsite OTR Rim Inspection & Certification™

**OTR Wheel & Rim Certification On-Site
Haulage & Loading 2015 Presentation**

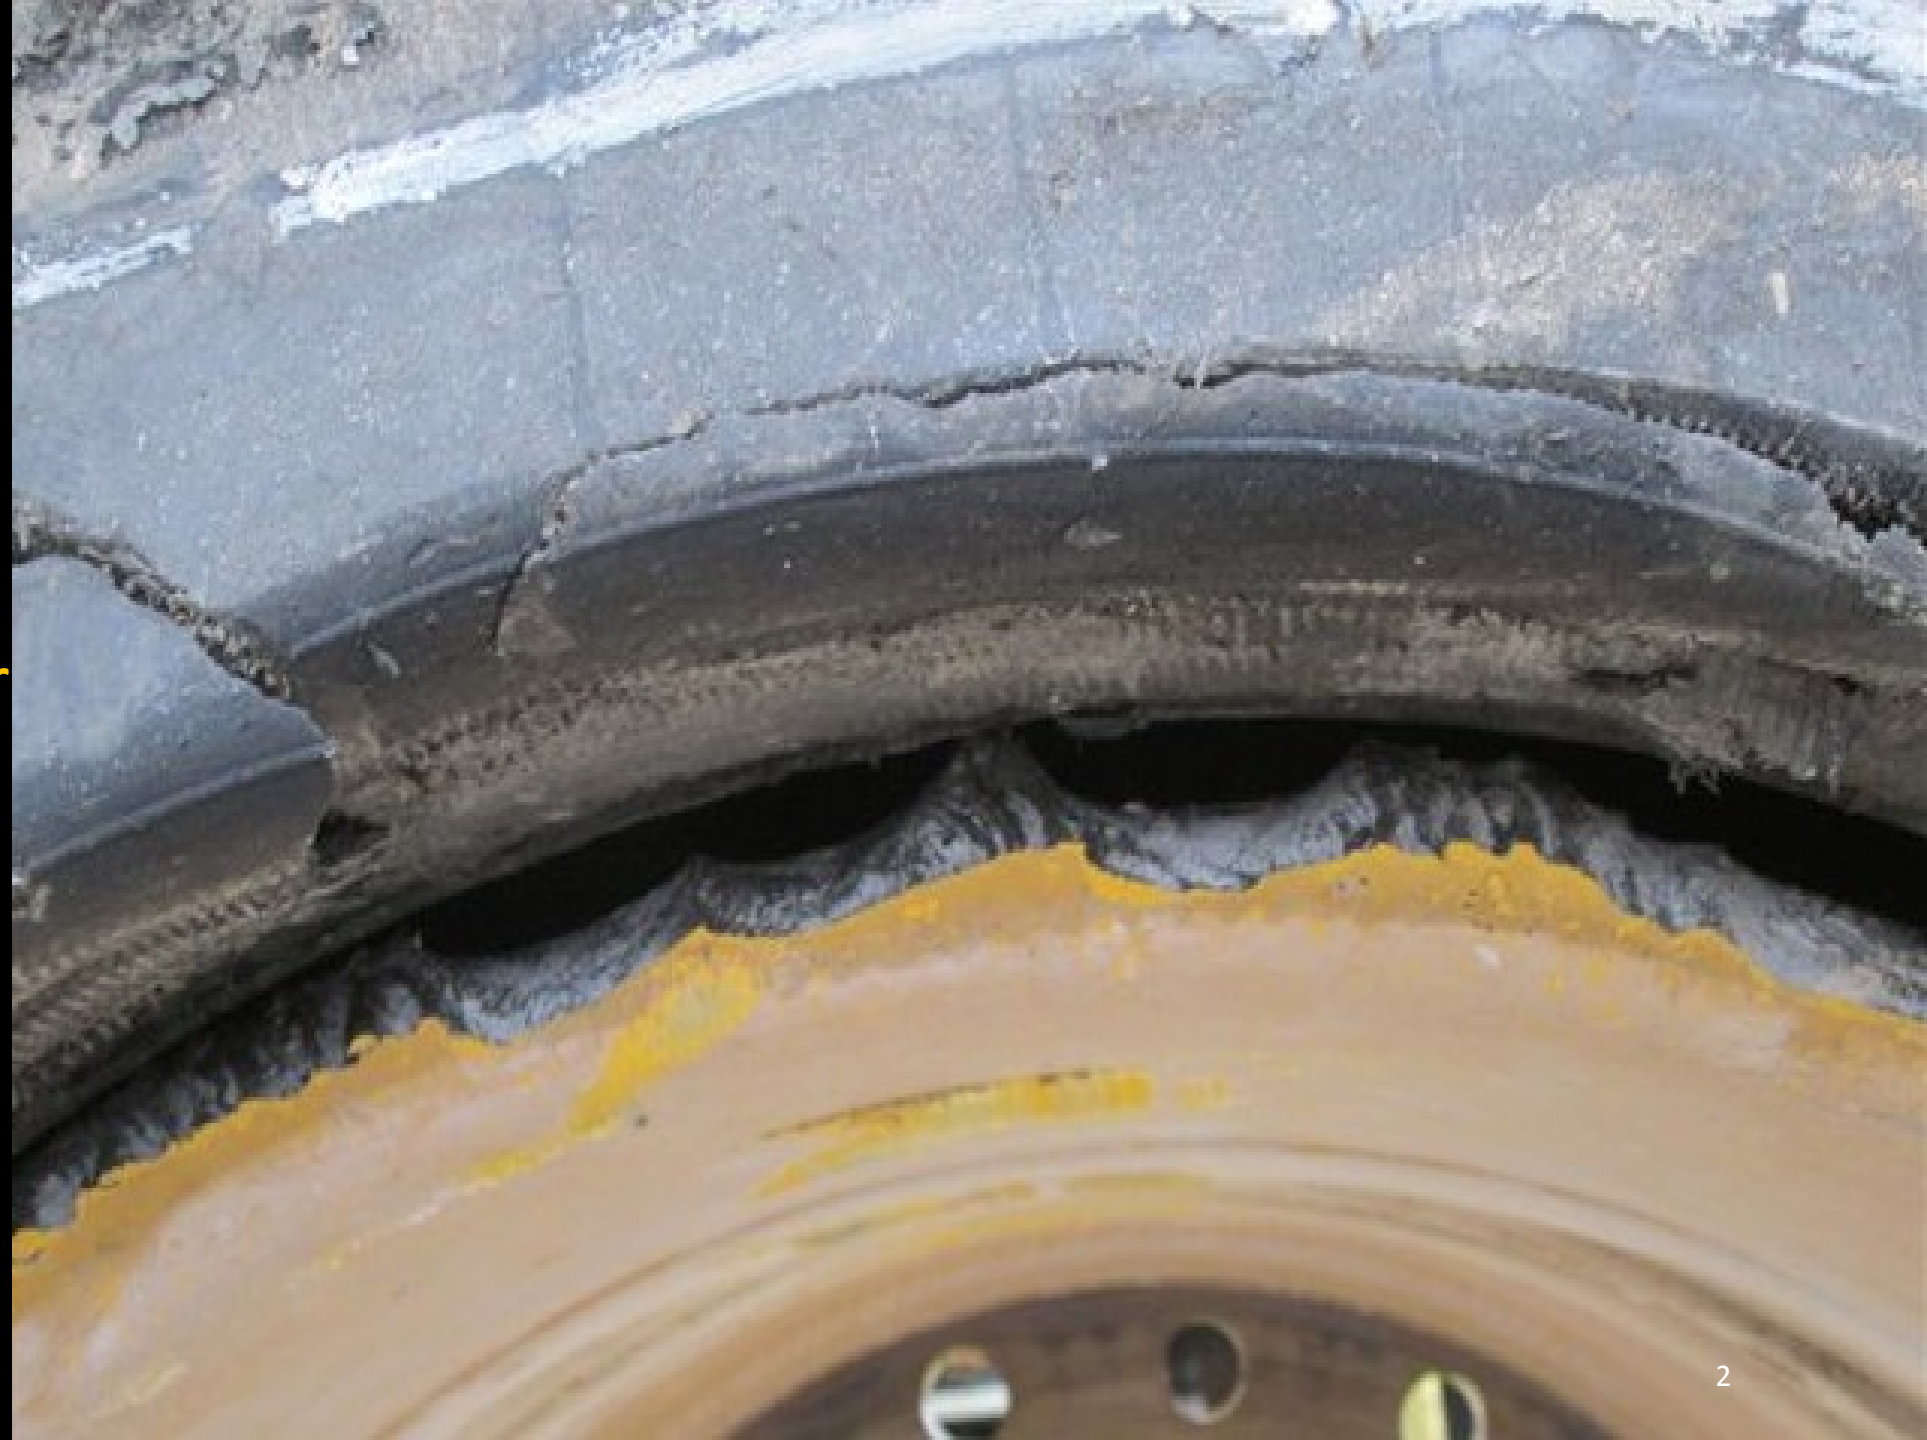
25 inch 3 pc loader
wheel with
catastrophic
failure /separation
of the Back
section/Flange
from its base

Why did this
occur?

Failure to conduct a
comprehensive inspection of
the OTR Wheel Assembly using established
examination criteria

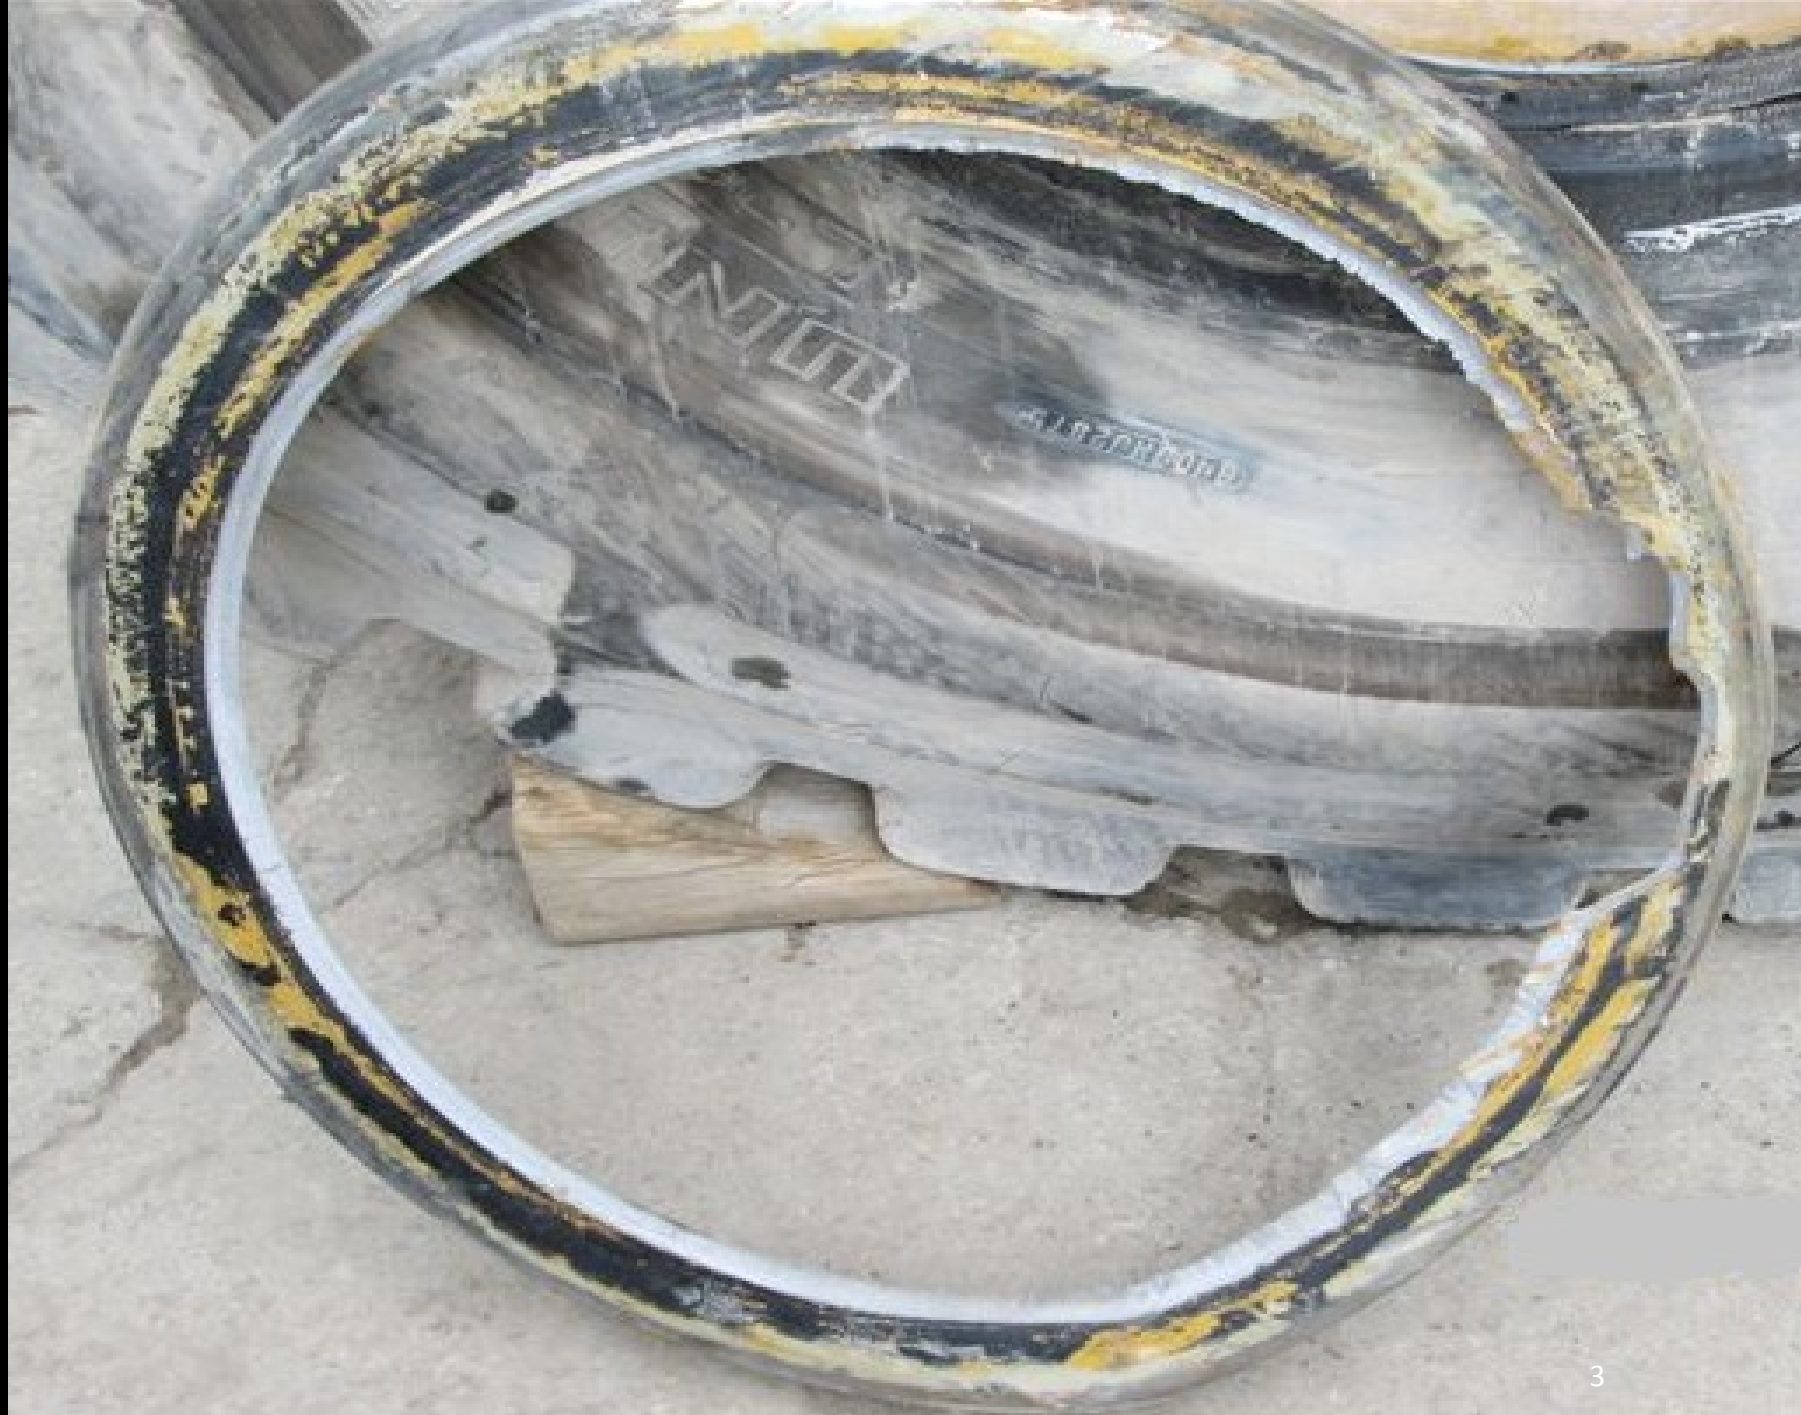
The separated
Back/flange section

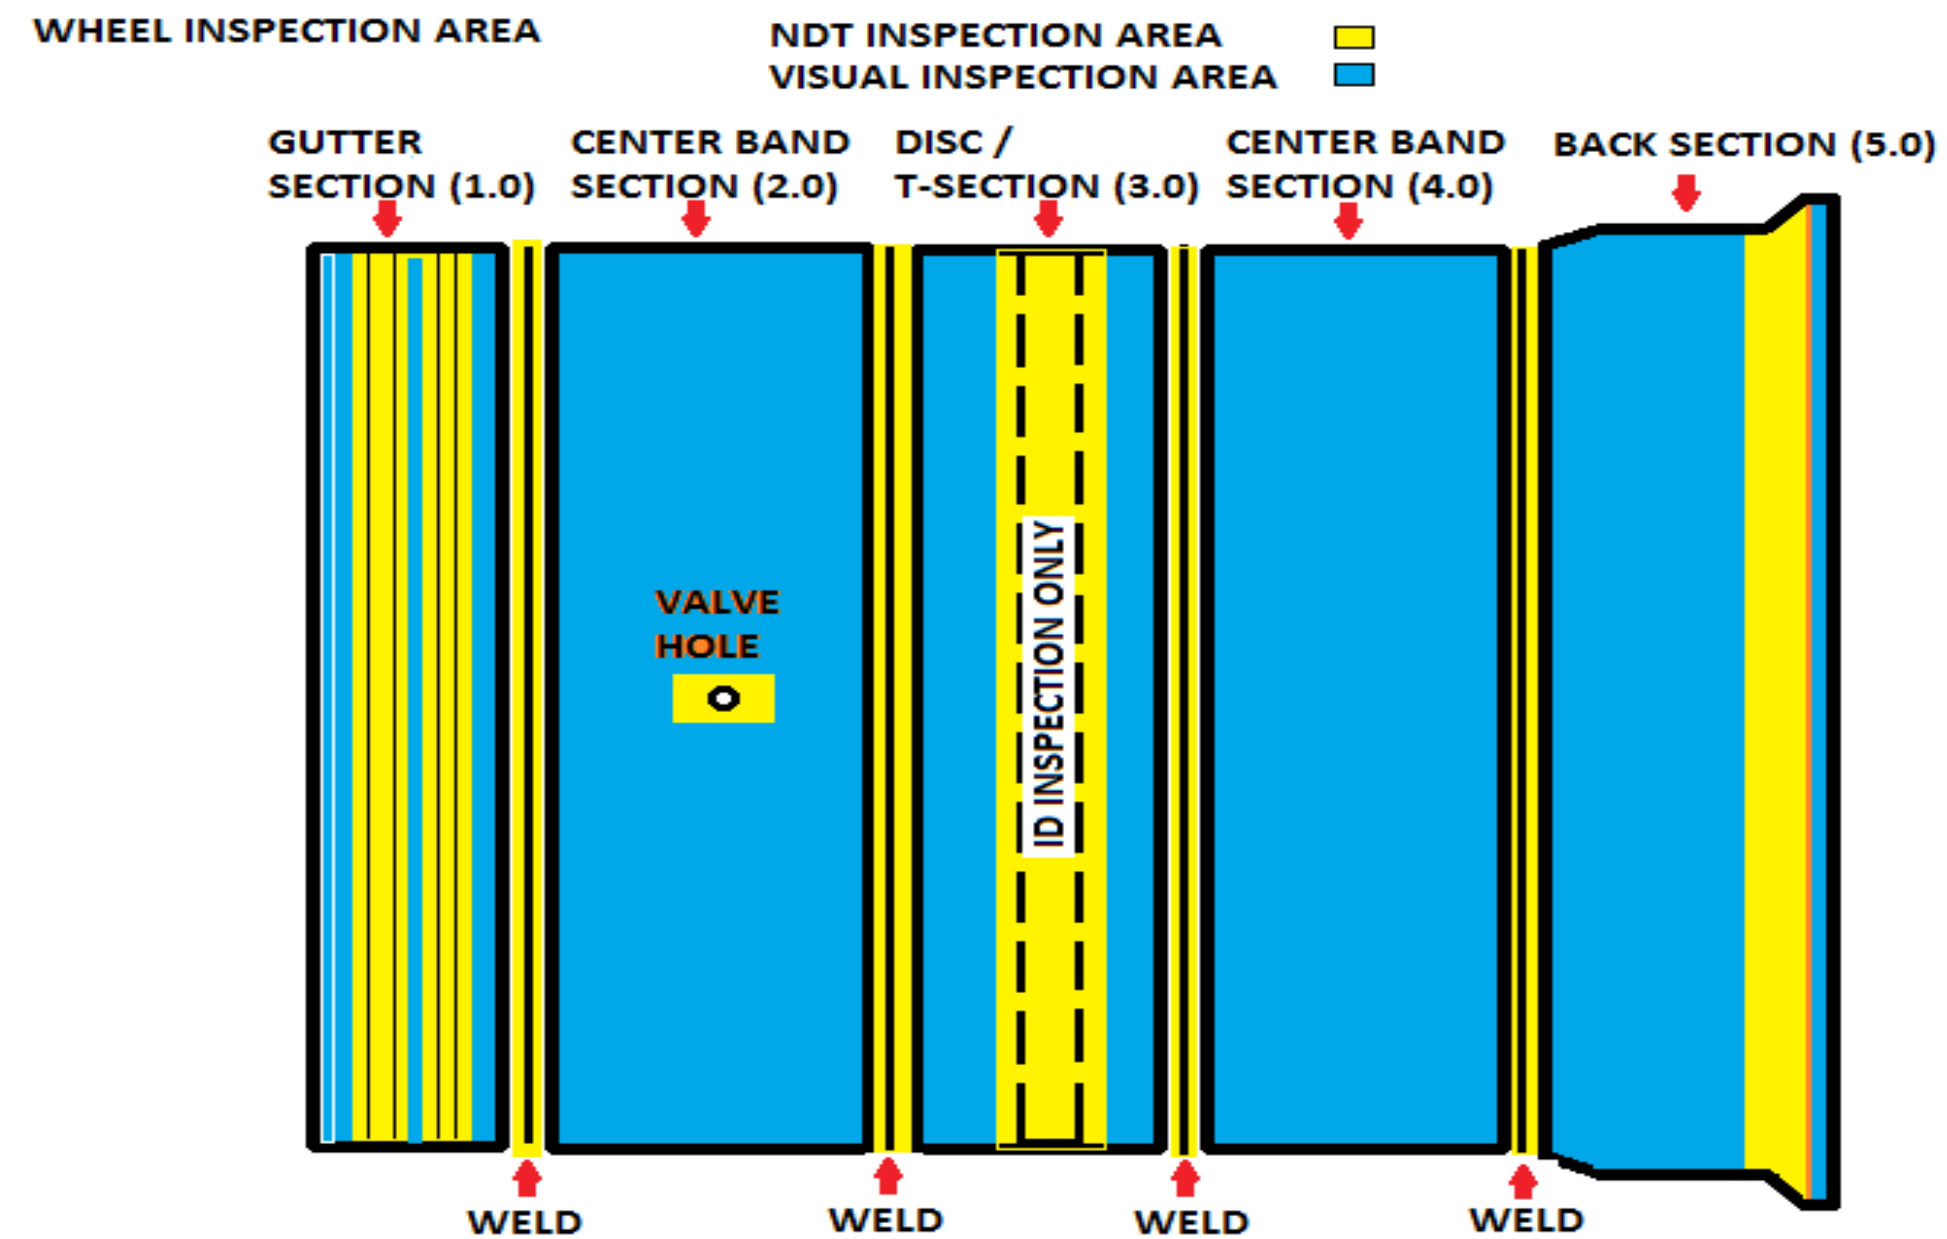
Figure 1: Inspection Diagram

NDT inspection method

- ACFM/ alternating current field measurement under ASTM E2261
- Traditional (MPI) magnetic particle inspection under ASTM E1444 to provide a visual medium for documentation
- Both of these methods are electromagnetic and are recognized worldwide
- Criteria for a defect is the same as within appendix B of Australian Standard AS4457.1 on OTR Wheels, Rims and Tires.

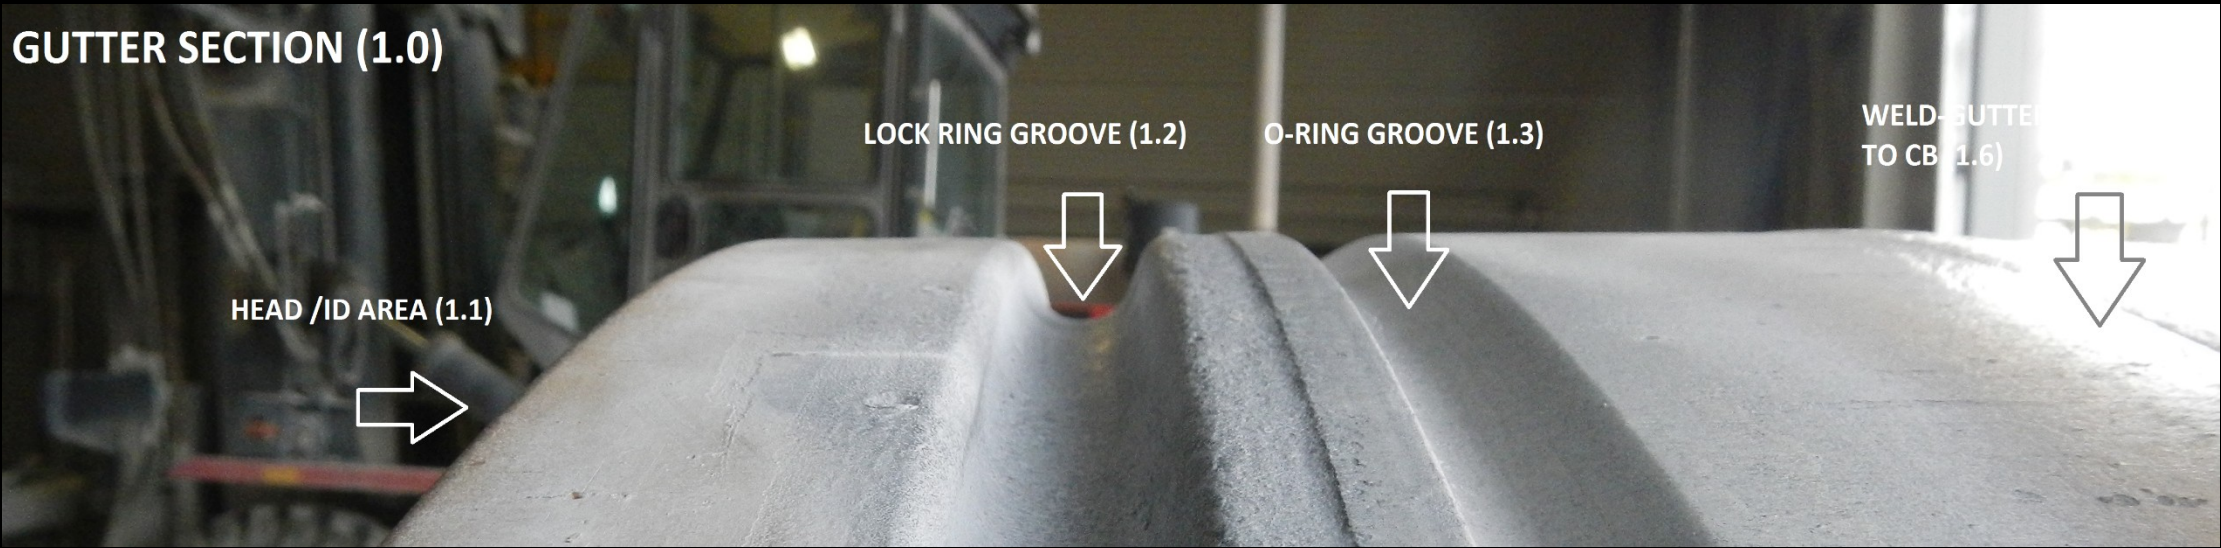
Figure 2: Gutter Section Criteria Diagram

GUTTER SECTION (1.0)

RIM SECTION	REGION	VISUAL	NDT	AREA SHOULD BE VOID OF THE FOLLOWING
GUTTER SECTION (1.0)				
1.1 (OD)	HEAD /ID AREA	X		CRACKED, EXCESSIVE MECHANICAL DAMAGE
1.2 (OD)	LOCK RING GROOVE	X	X	CRACKED, MECHANICAL DAMAGE, +2mm WEAR (HDT)
1.3 (OD)	O-RING GROOVE	X	X	CRACKED, MECHANICAL DAMAGE, CORROSION
1.4 (ID)	MOUNT TAPER (Rim Only)	X	X	MECHANICAL DAMAGE TO TAPER, CRACKED
1.5 (ID)	VALVE PROTECTOR	X	X	CRACKED, BENT OR REMOVED
1.6 (OD & ID)	WELD- GUTTER /CB	X	X	CRACKED, EXCESSIVE CORROSION

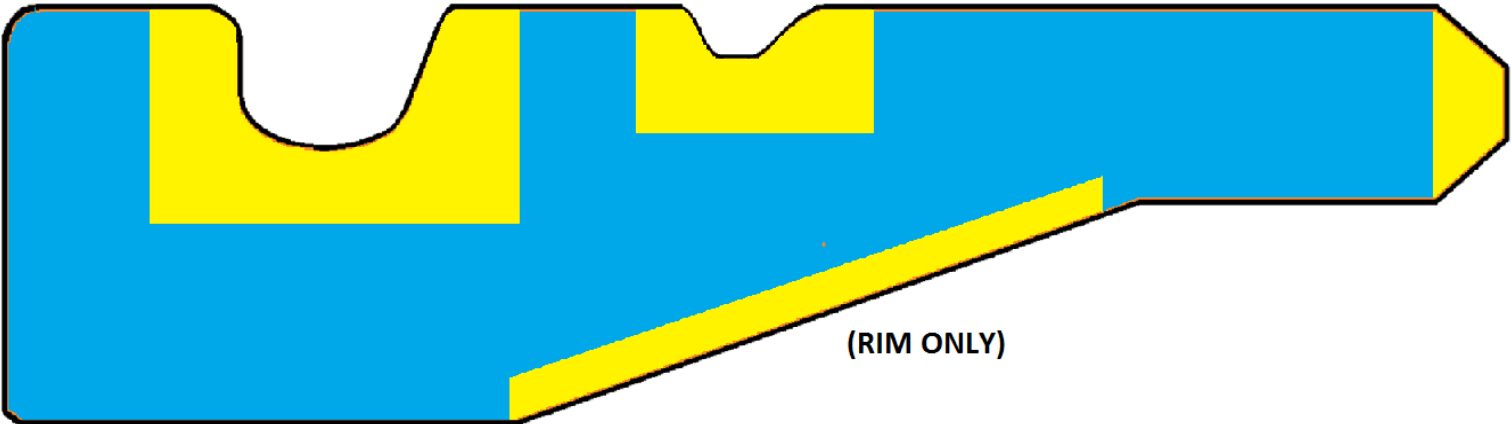
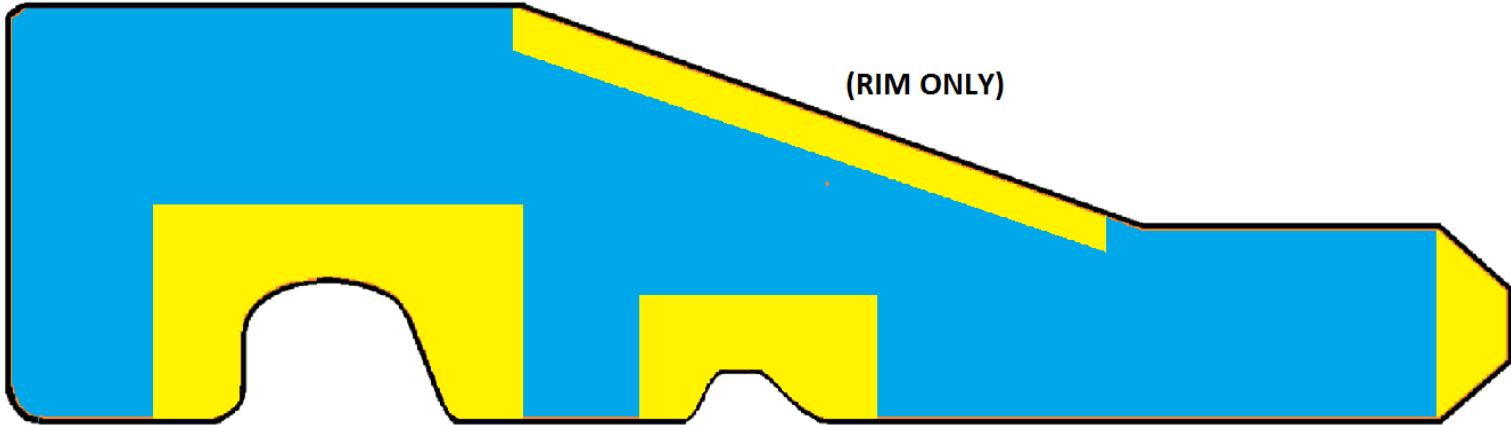
Figure 3: Inspection Diagram- Gutter Section

**GUTTER SECTION:
INSPECTION AREA**

NDT INSPECTION AREA

VISUAL INSPECTION AREA

ROUNDNESS MEASUREMENT AREA

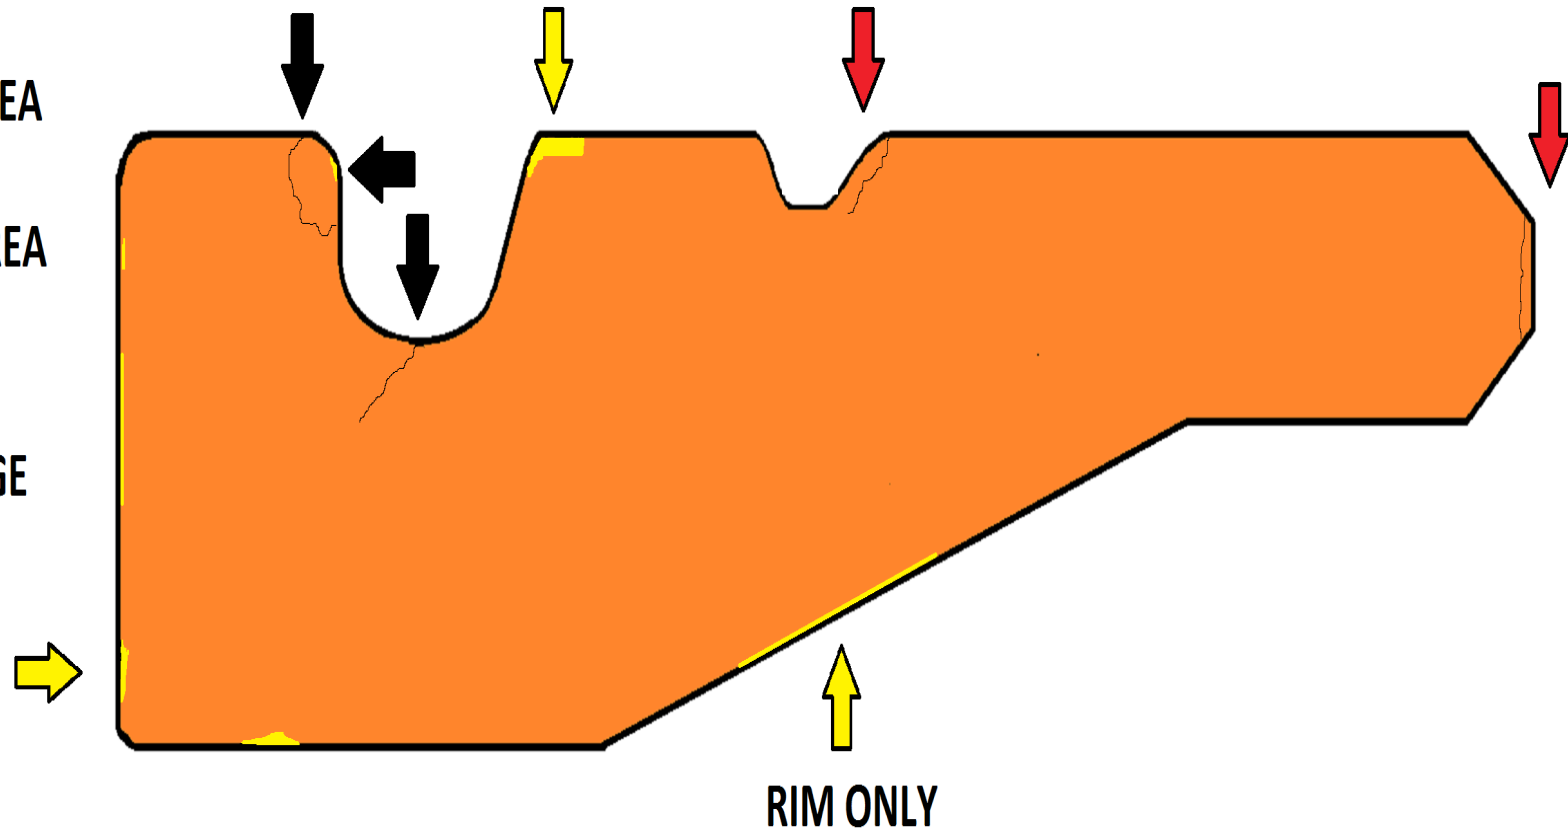
Figure 4: Gutter Section Service Diagram

GUTTER SECTION (1.0)

CRACKING, WEAR & MECHANICAL DAMAGE

↓ MAJOR CRACKING AREA

↓ MINOR CRACKING AREA

↓ WEAR & MECHANICAL DAMAGE

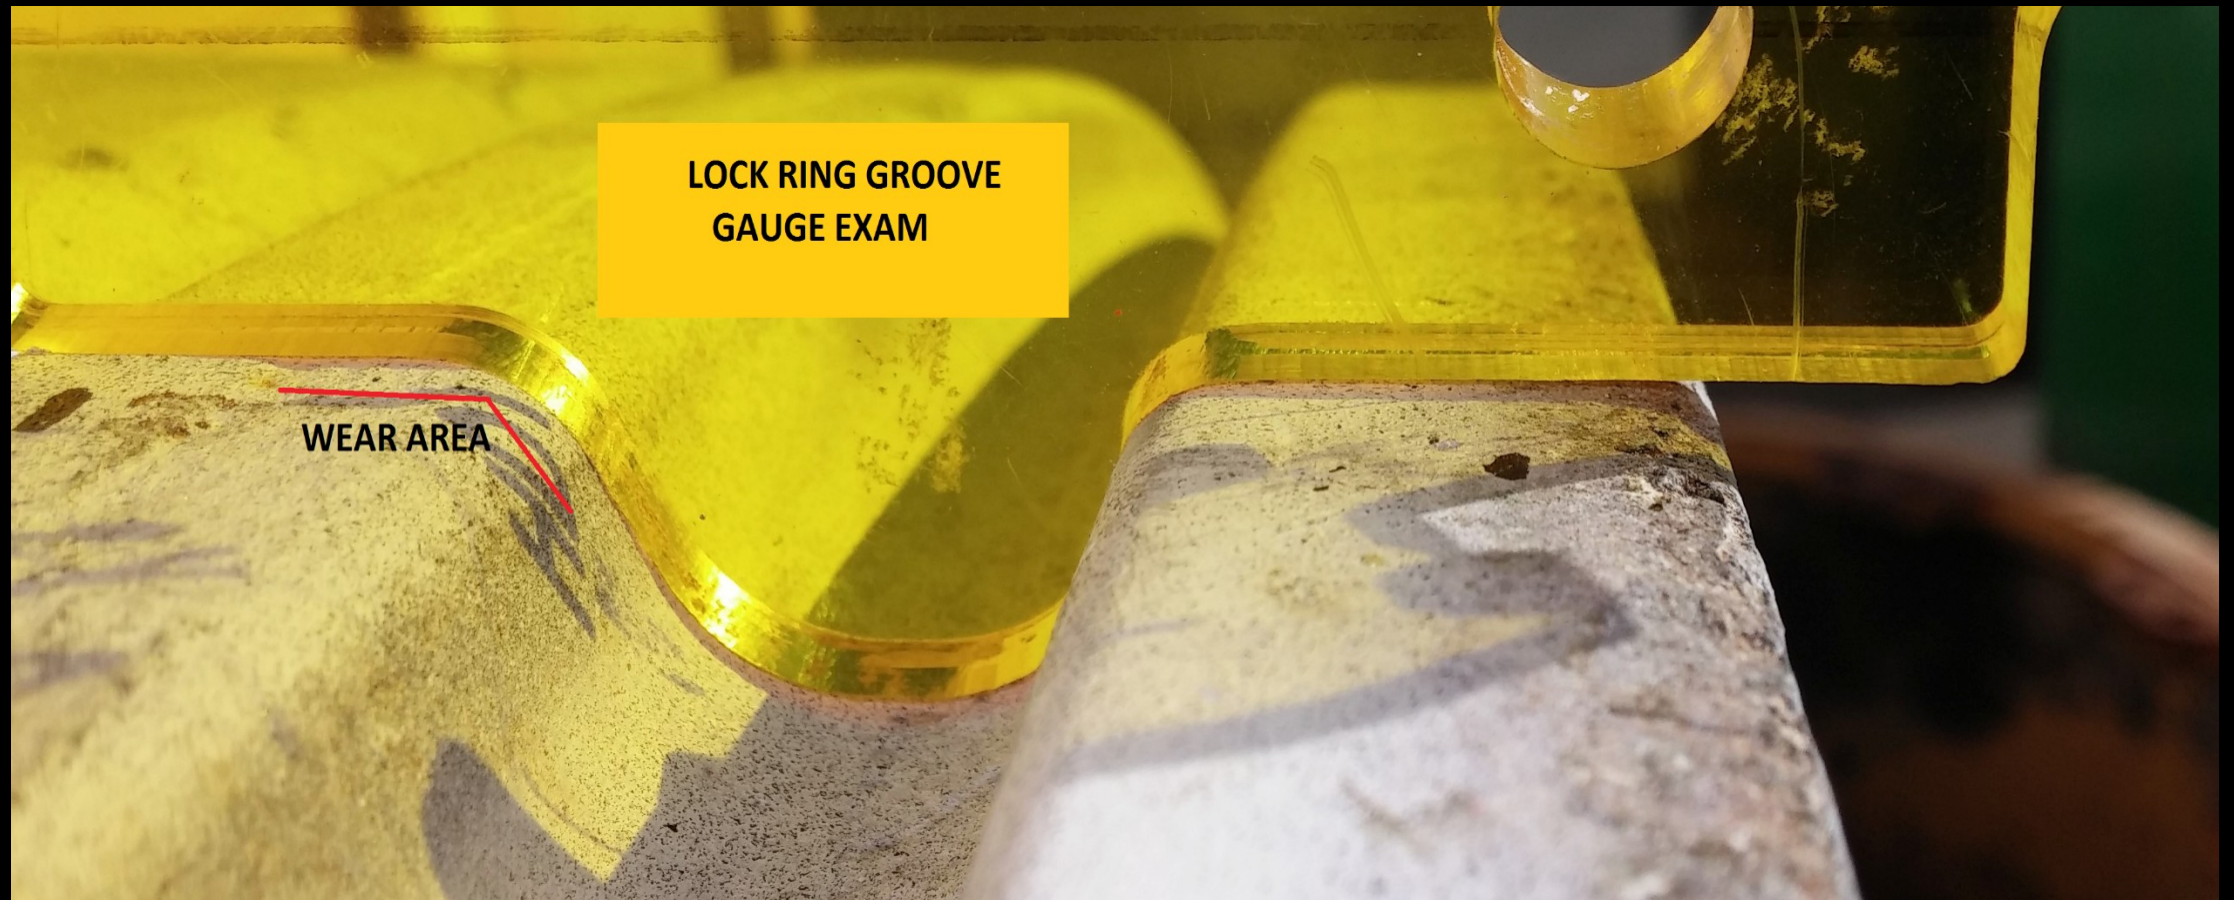
Figure 5: Gutter Gauge

Gutter Gauge : Wear exam

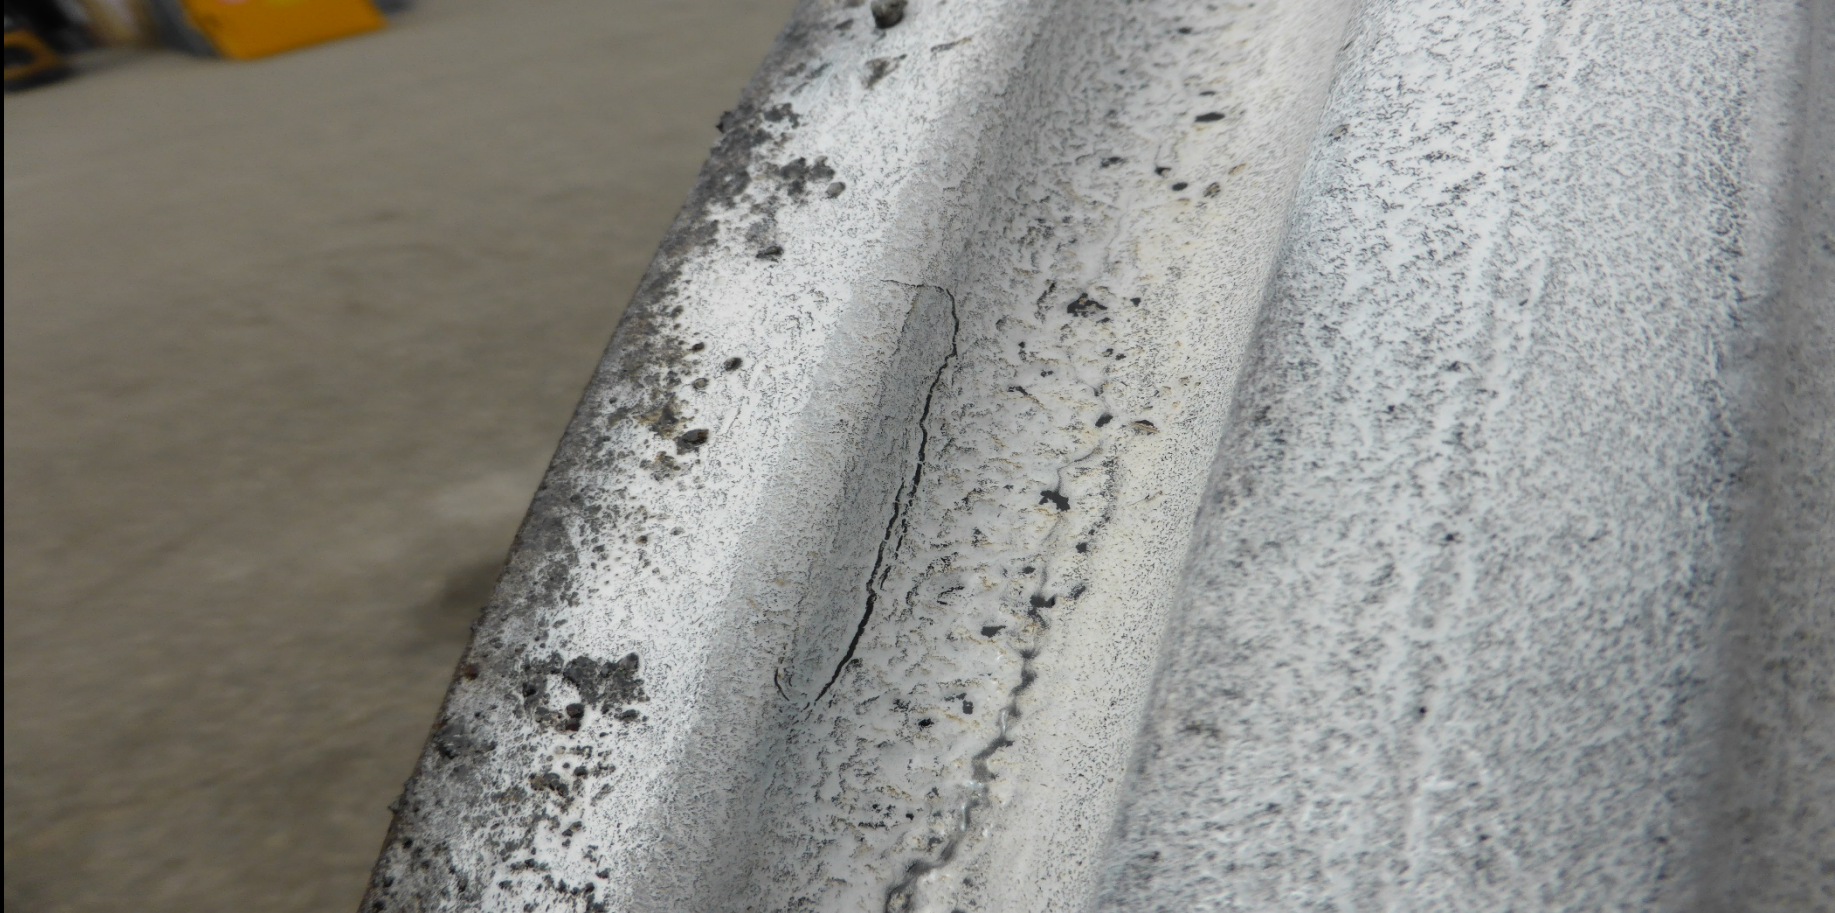
Figure 6: Lock Ring Groove Crack

Lock Ring Gutter Crack- 50mm long / 2mm deep

Common to find fatigue cracking in numerous positions around the lock ring groove.

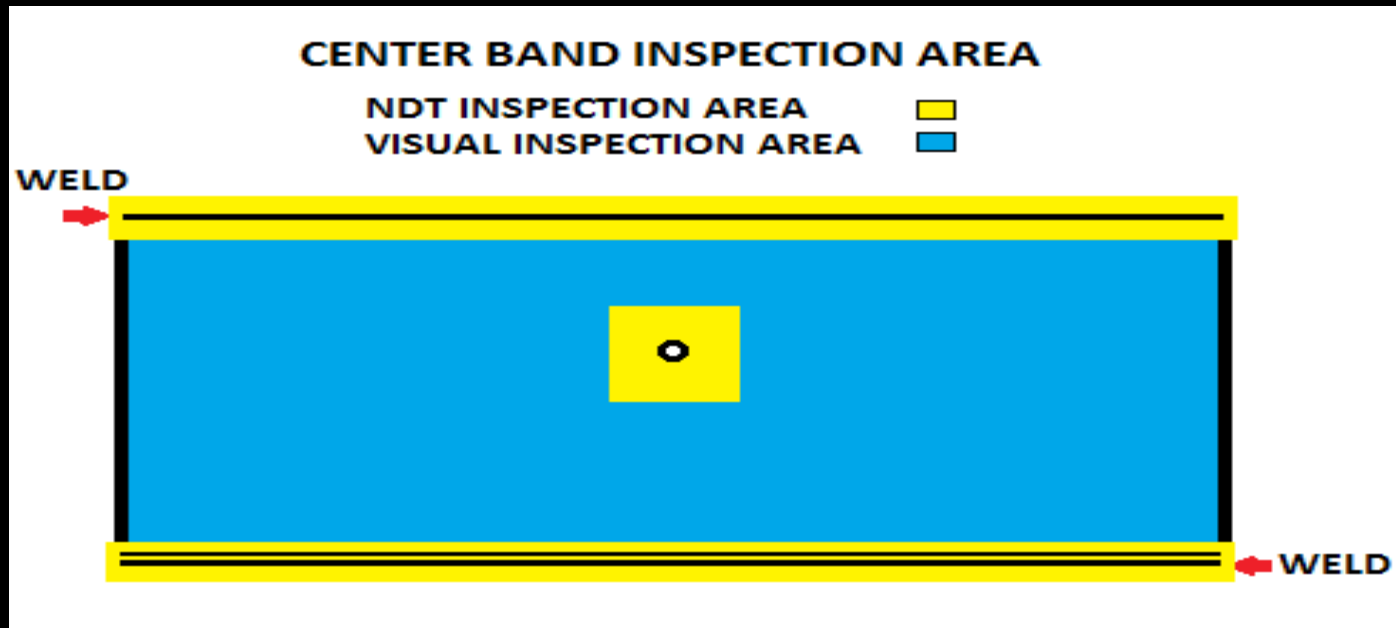
Figure 7: Center Band Section Criteria Diagram

RIM SECTION	REGION	VISUAL	NDT	AREA SHOULD BE VOID OF THE FOLLOWING
CENTER BAND (2.0/ 4.0)				
2.1/4.1 (OD)	RIM SURFACE	X		CRACKED, EXCESSIVE CORROSION
2.2/4.2 (OD&ID)	VALVE HOLES CT BORE/ ¹ / ₂ & ³ / ₄ NPT	X	X	CRACKED, BROKEN BRASS, THREAD DAMAGE
2.3/4.3 (OD&ID)	CB WELD 1 / T-SECT.	X	X	CRACKED, EXCESSIVE CORROSION
2.4/4.4 (OD&ID)	CB WELD 2 / T-SECT.	X	X	CRACKED, EXCESSIVE CORROSION

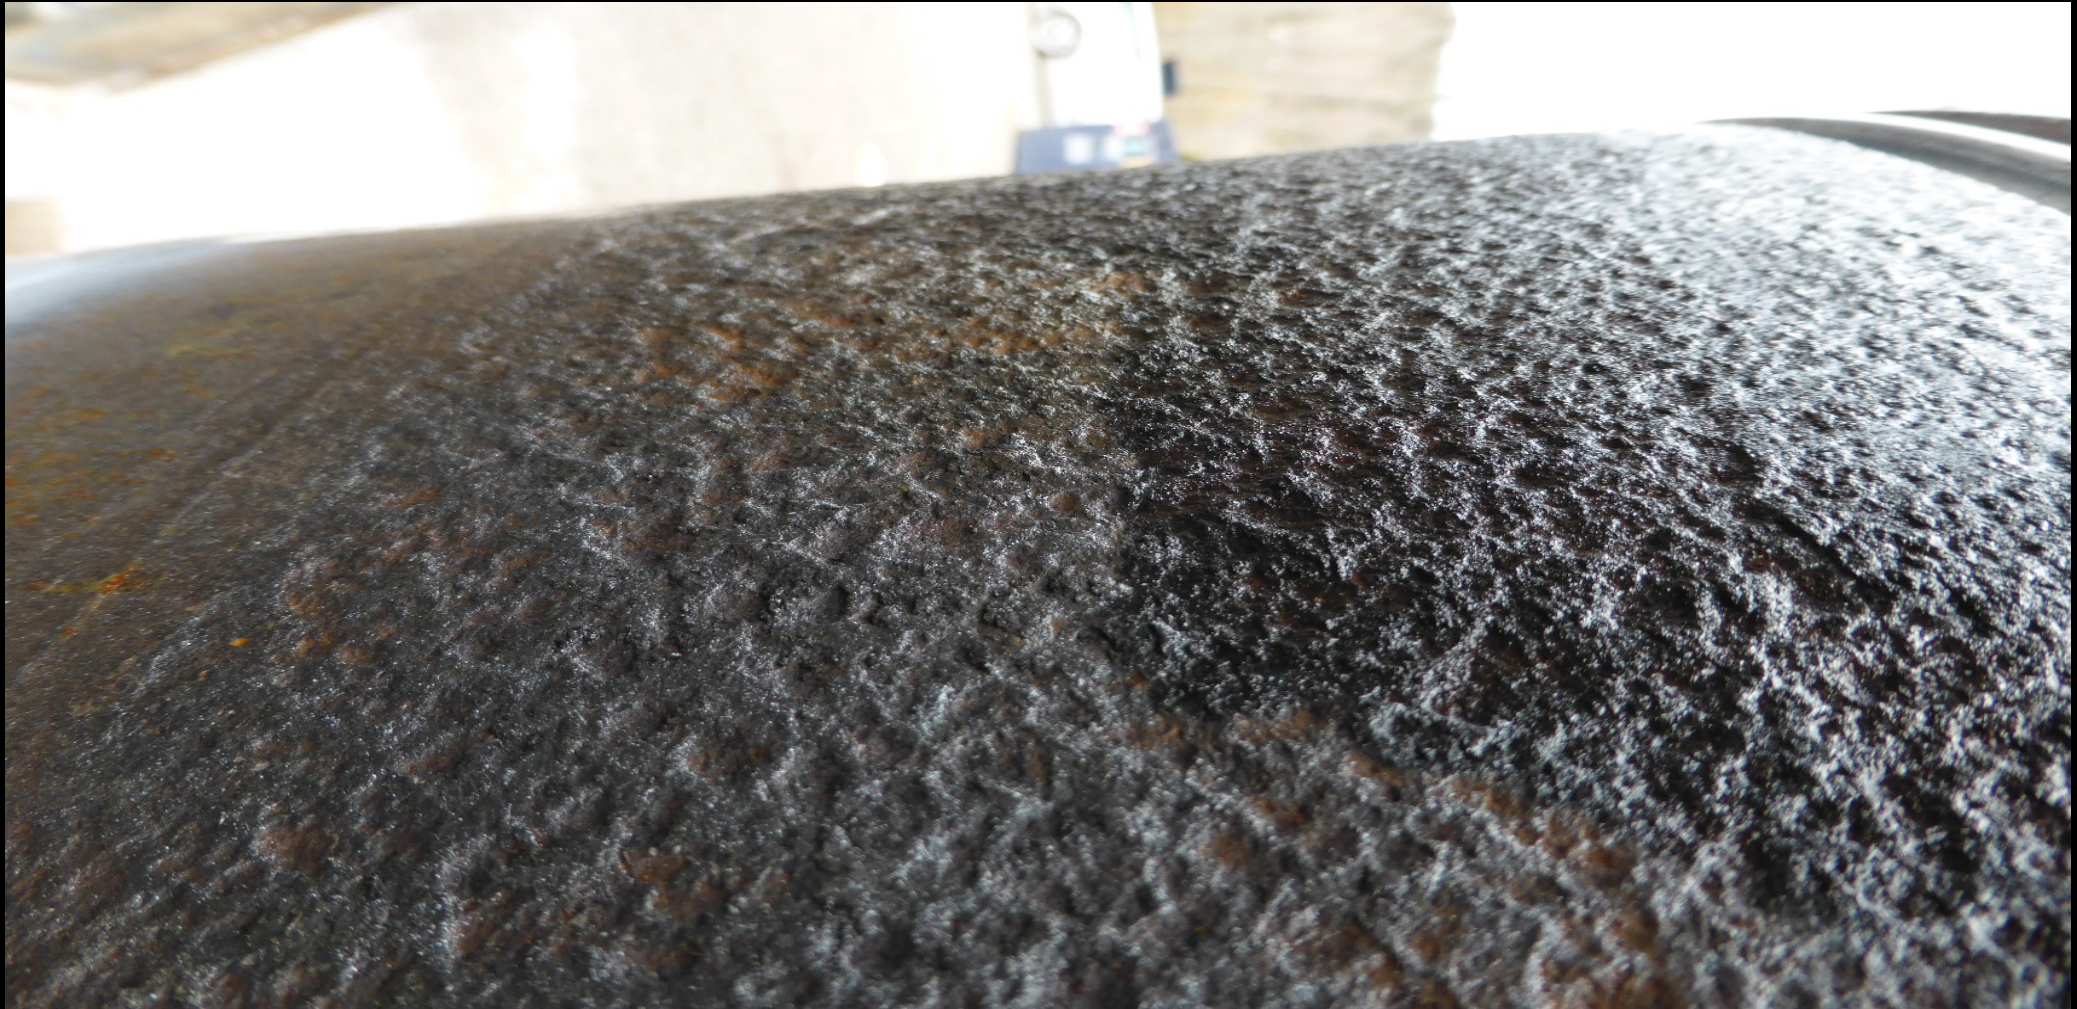
Figure 8: CB Corrosion Sample

Center band corrosion- under the Bead Band

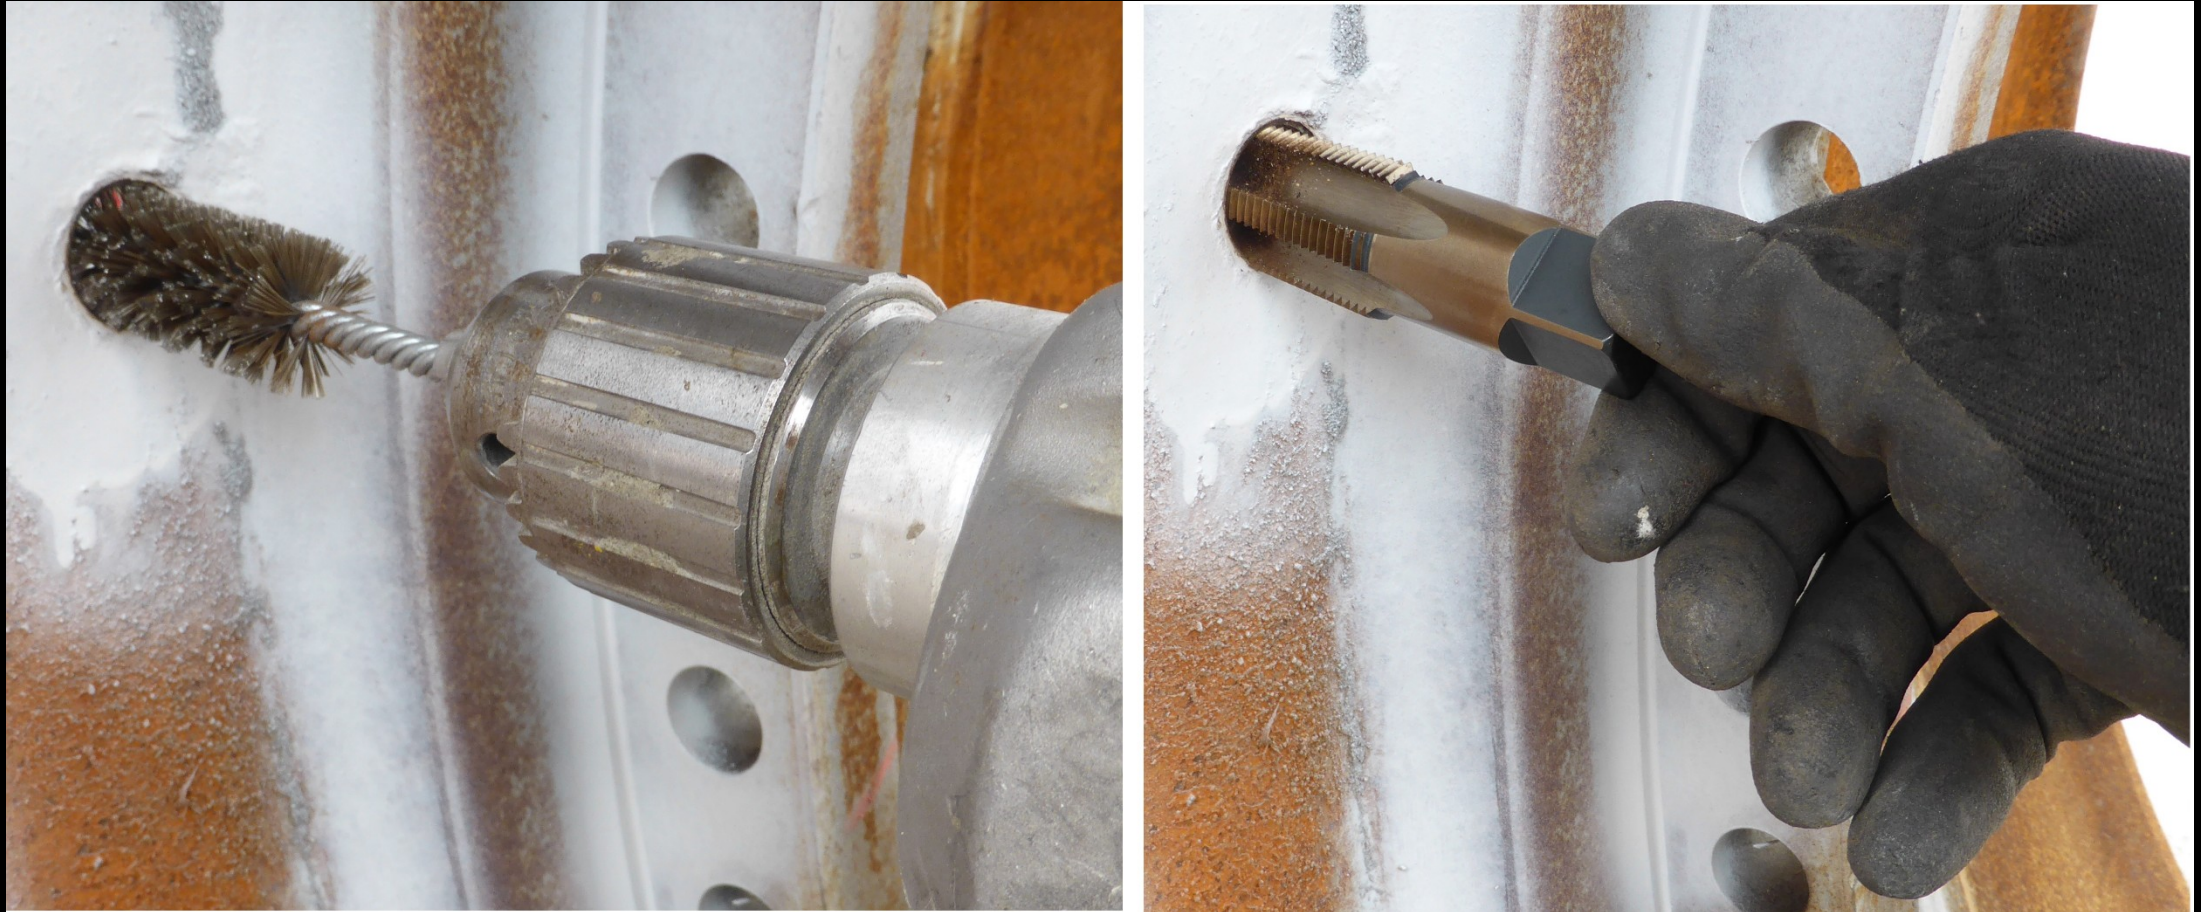
Figure 9: NPT valve hole Maintenance

Maintenance of the NPT valves

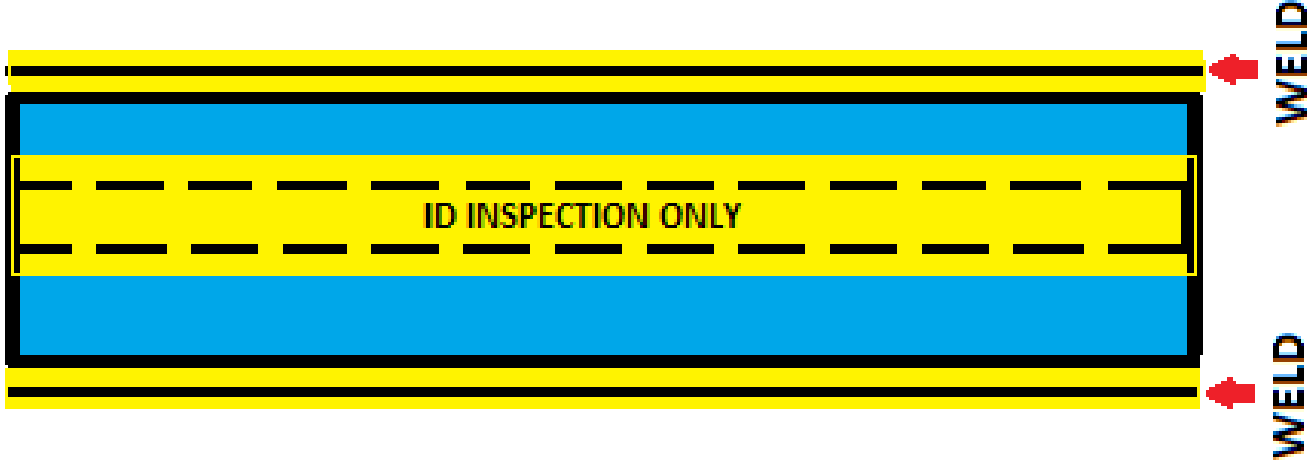
Figure 10: Disc Area Criteria Diagram

RIM SECTION	REGION	VISUAL	NDT	AREA SHOULD BE VOID OF THE FOLLOWING
DISC/T-SECTION (3.0)	(WHEEL ONLY)			
3.1 (ID)	ID WELDS	X	X	CRACKED
3.2 (ID)	STUD HOLES	X	X	CRACKED, DEFORMATION
