OTR Rim Certification, Inc.

Onsite OTR Rim Inspection & Certification™

**OTR Wheel & Rim Certification On-Site
Haulage & Loading 2015 Presentation**

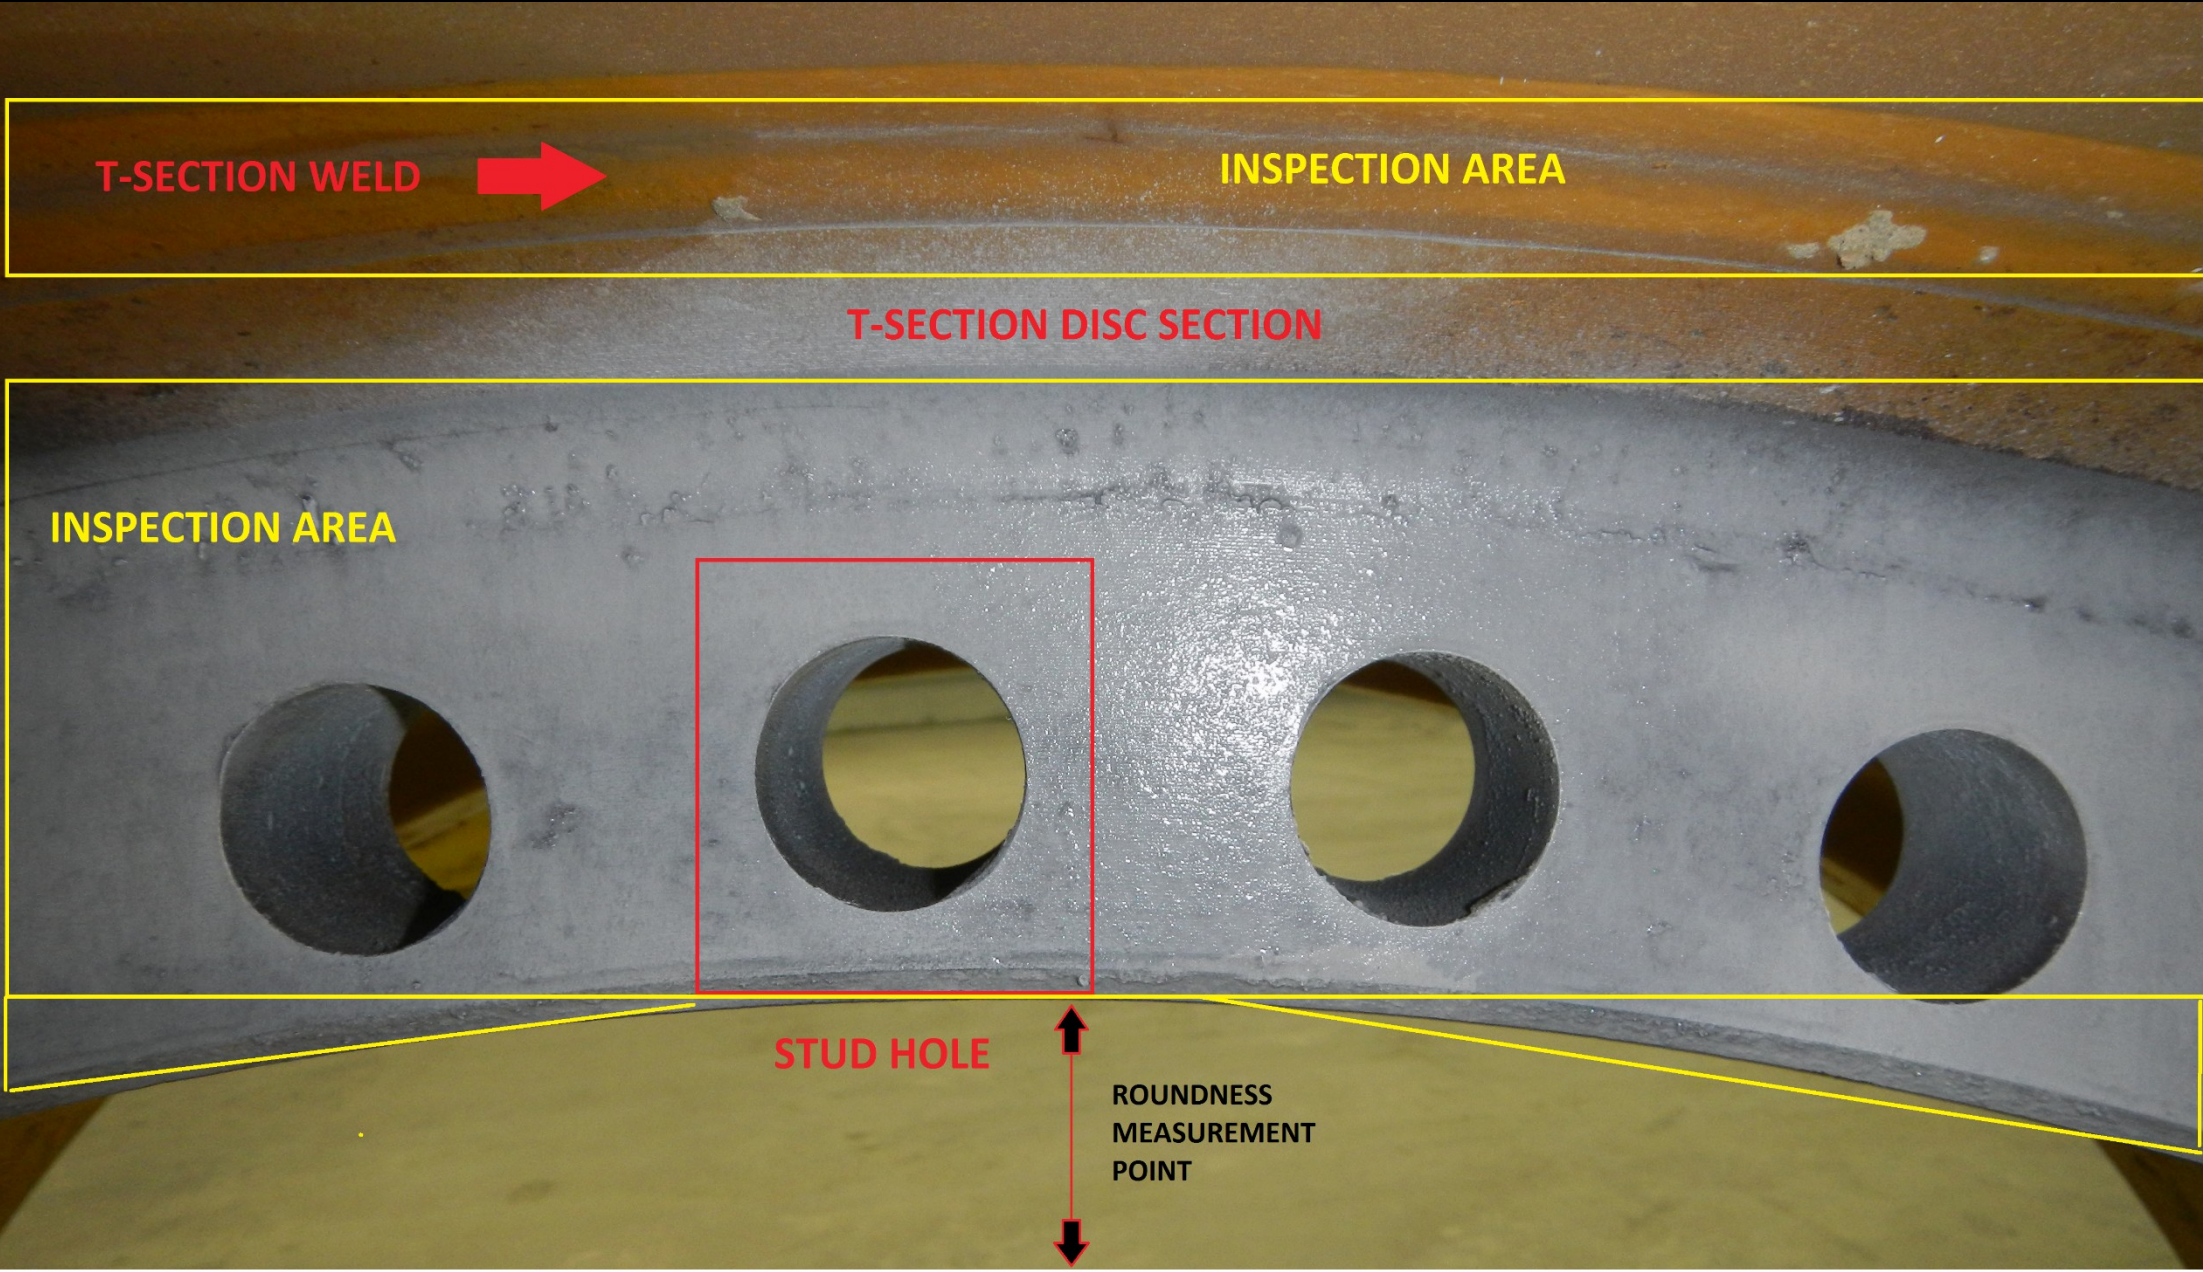
Figure 11: Disc Area Inspection Diagram

DISC/ T-SECTION INSPECTION AREA

NDT INSPECTION AREA ■
 VISUAL INSPECTION AREA ■

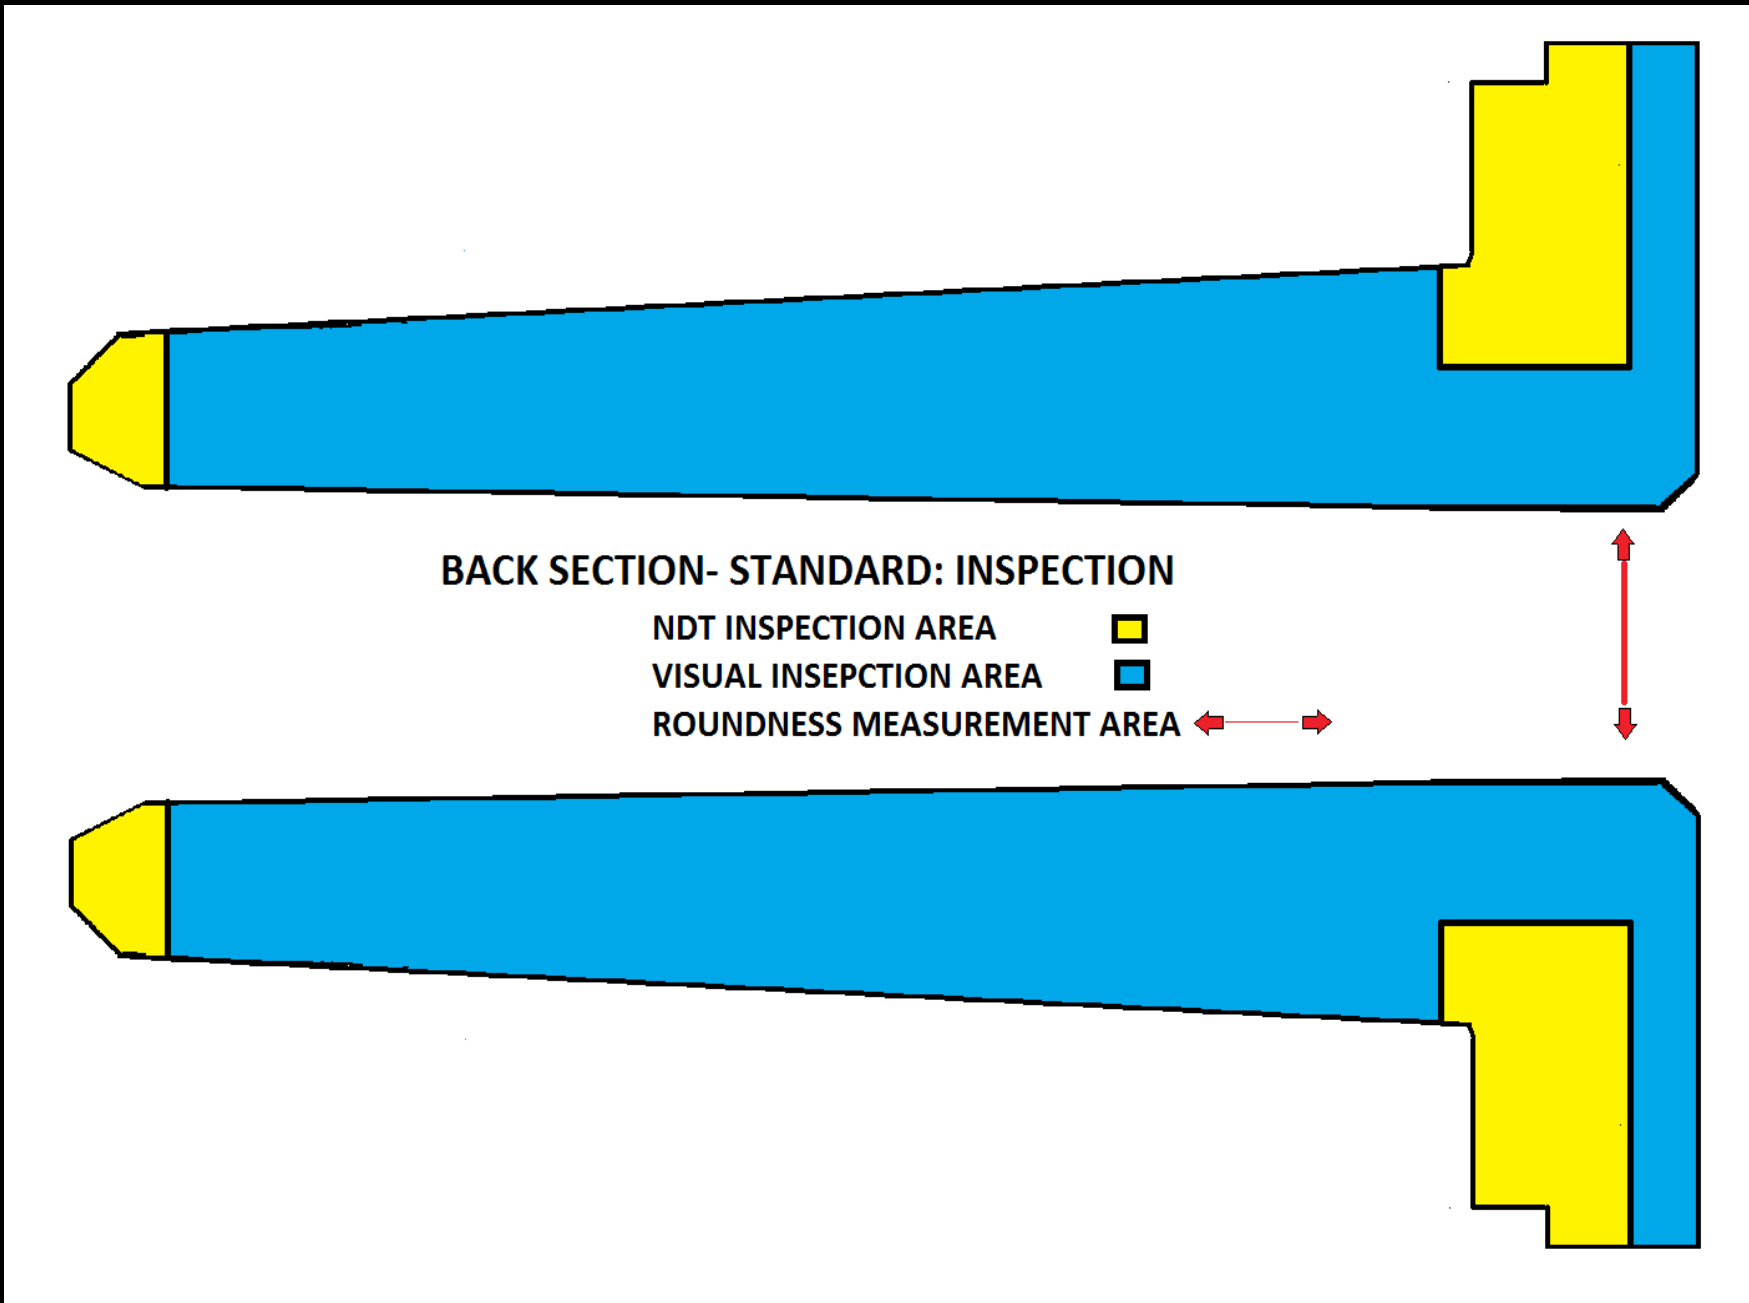
Figure 13: Standard Back Section Inspection Diagram

BACK SECTION (5.0)

WELD- CB TO BACK SECTION (5.1)

TIRE BEAD AREA (5.2)
(KNURLING)

TAPER (5.3)
FLANGE AREA

BACK FACE / ID AREA (5.4)

RIM SECTION	REGION	VISUAL	NDT	AREA SHOULD BE VOID OF THE FOLLOWING
BACK SECTION (5.0)				
5.1 (OD&ID)	WELD - CB TO BACK	X	X	CRACKED, EXCESSIVE CORROSION
5.2 (OD)	TIRE BEAD AREA	X		MECHANICAL DAMAGE, +3mm WEAR
5.3 (OD)	LIP / TAPER	X	X	CRACKED, COMPRESSION, EXCESSIVE GALLING
5.4 (OD&ID)	BACK FACE / ID AREA	X		CRACKED, EXCESSIVE MECHANICAL DAMAGE

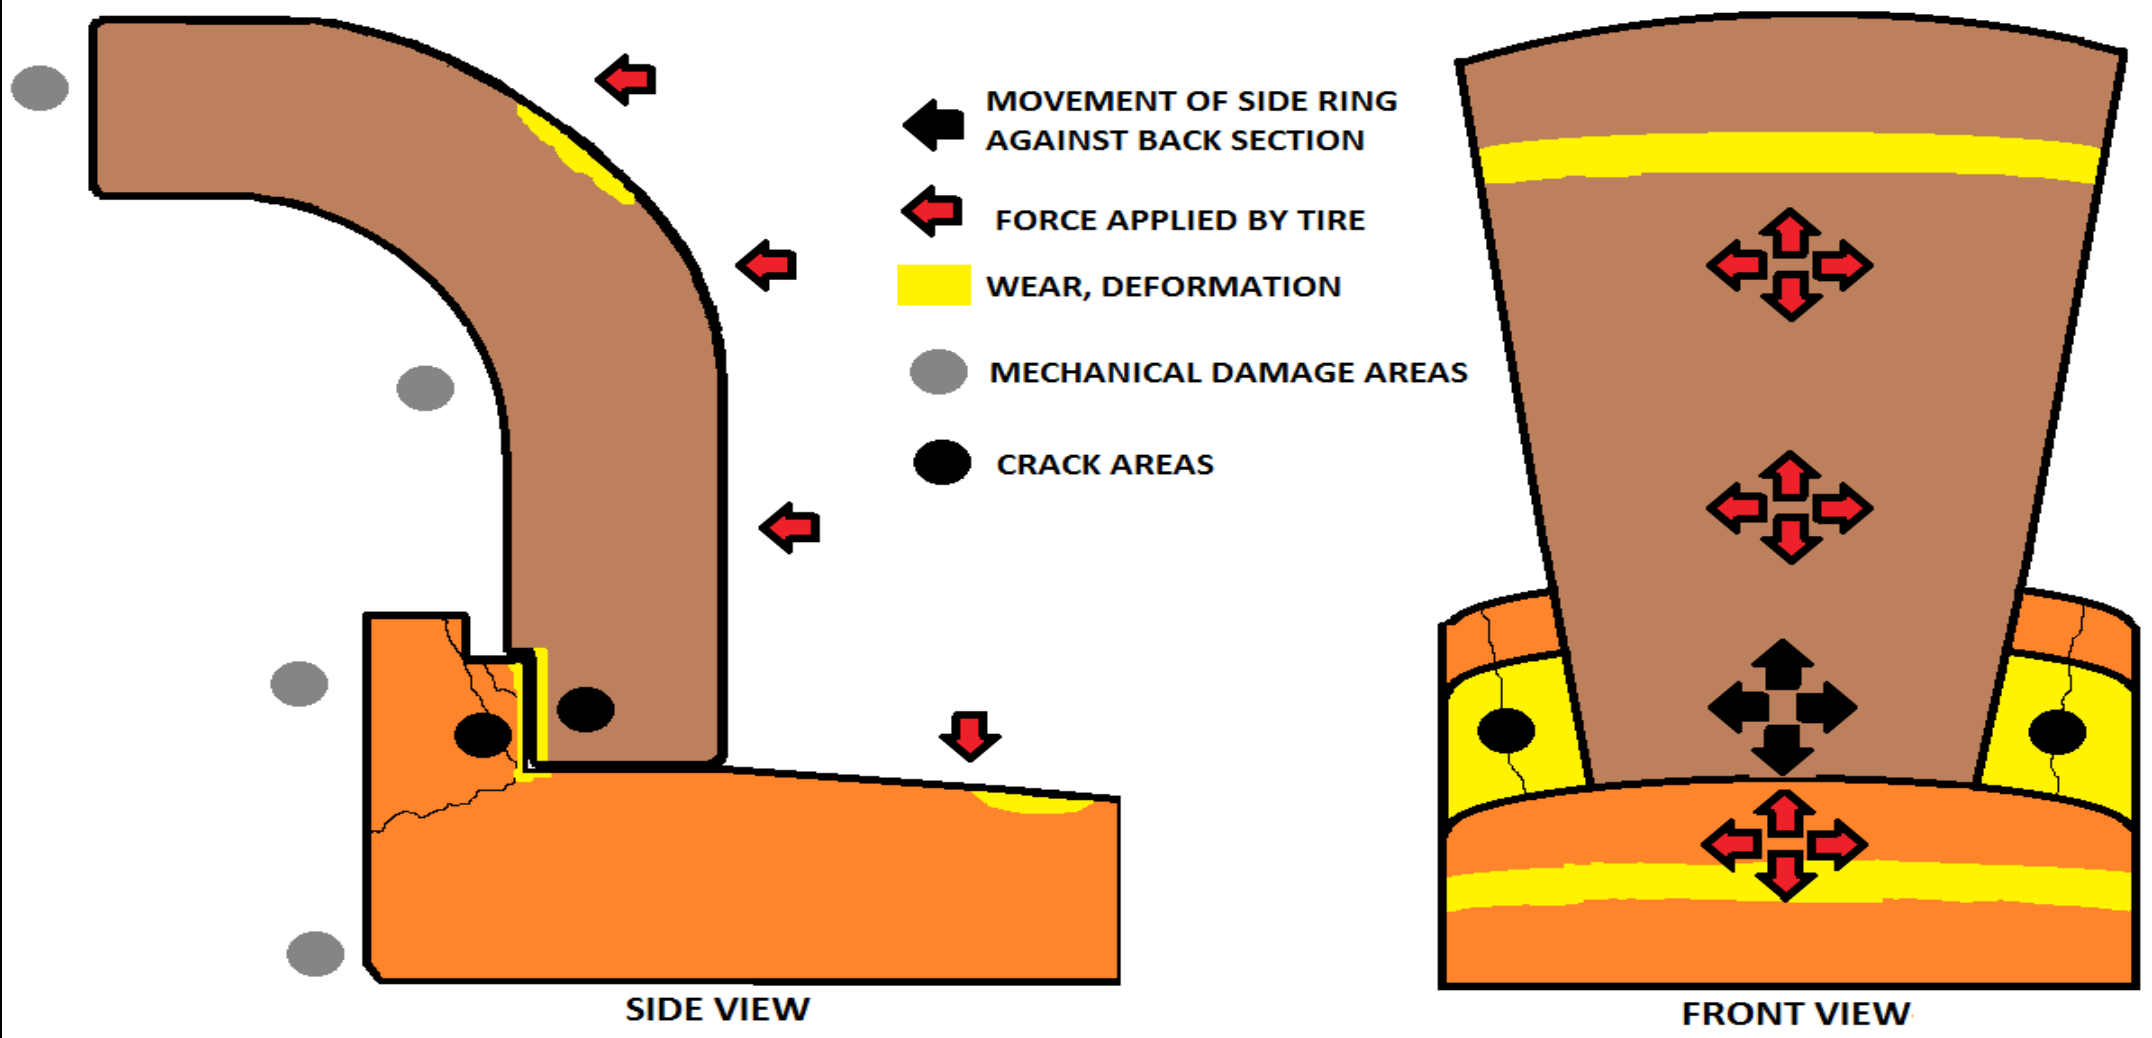
Figure 14: Service Diagram- Standard Back & Side ring

STANDARD BACK SECTION & SIDE RING DESIGN
 (SIDE RING & BACK SECTION ASSEMBLE AT 90 DEGREES)
SERVICE DIAGRAM

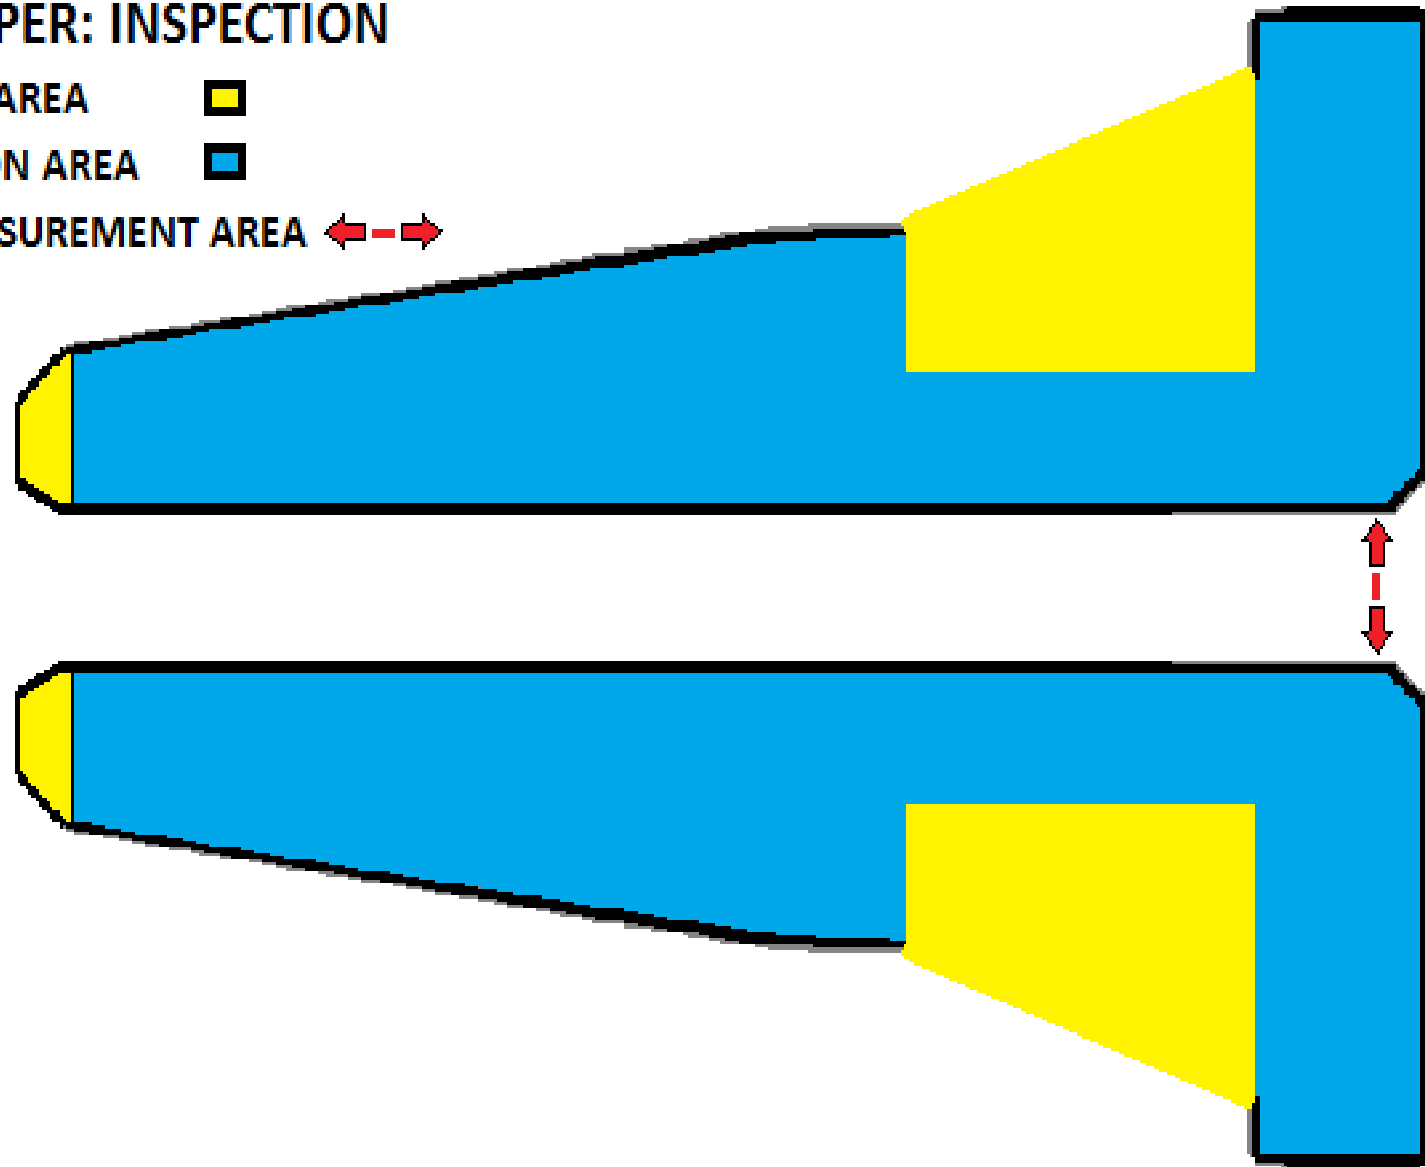
Figure 15: Taper Back Section Inspection Diagram

BACK SECTION-TAPER: INSPECTION

- NDT INSPECTION AREA ■
- VISUAL INSPECTION AREA ■
- ROUNDNESS MEASUREMENT AREA ↔

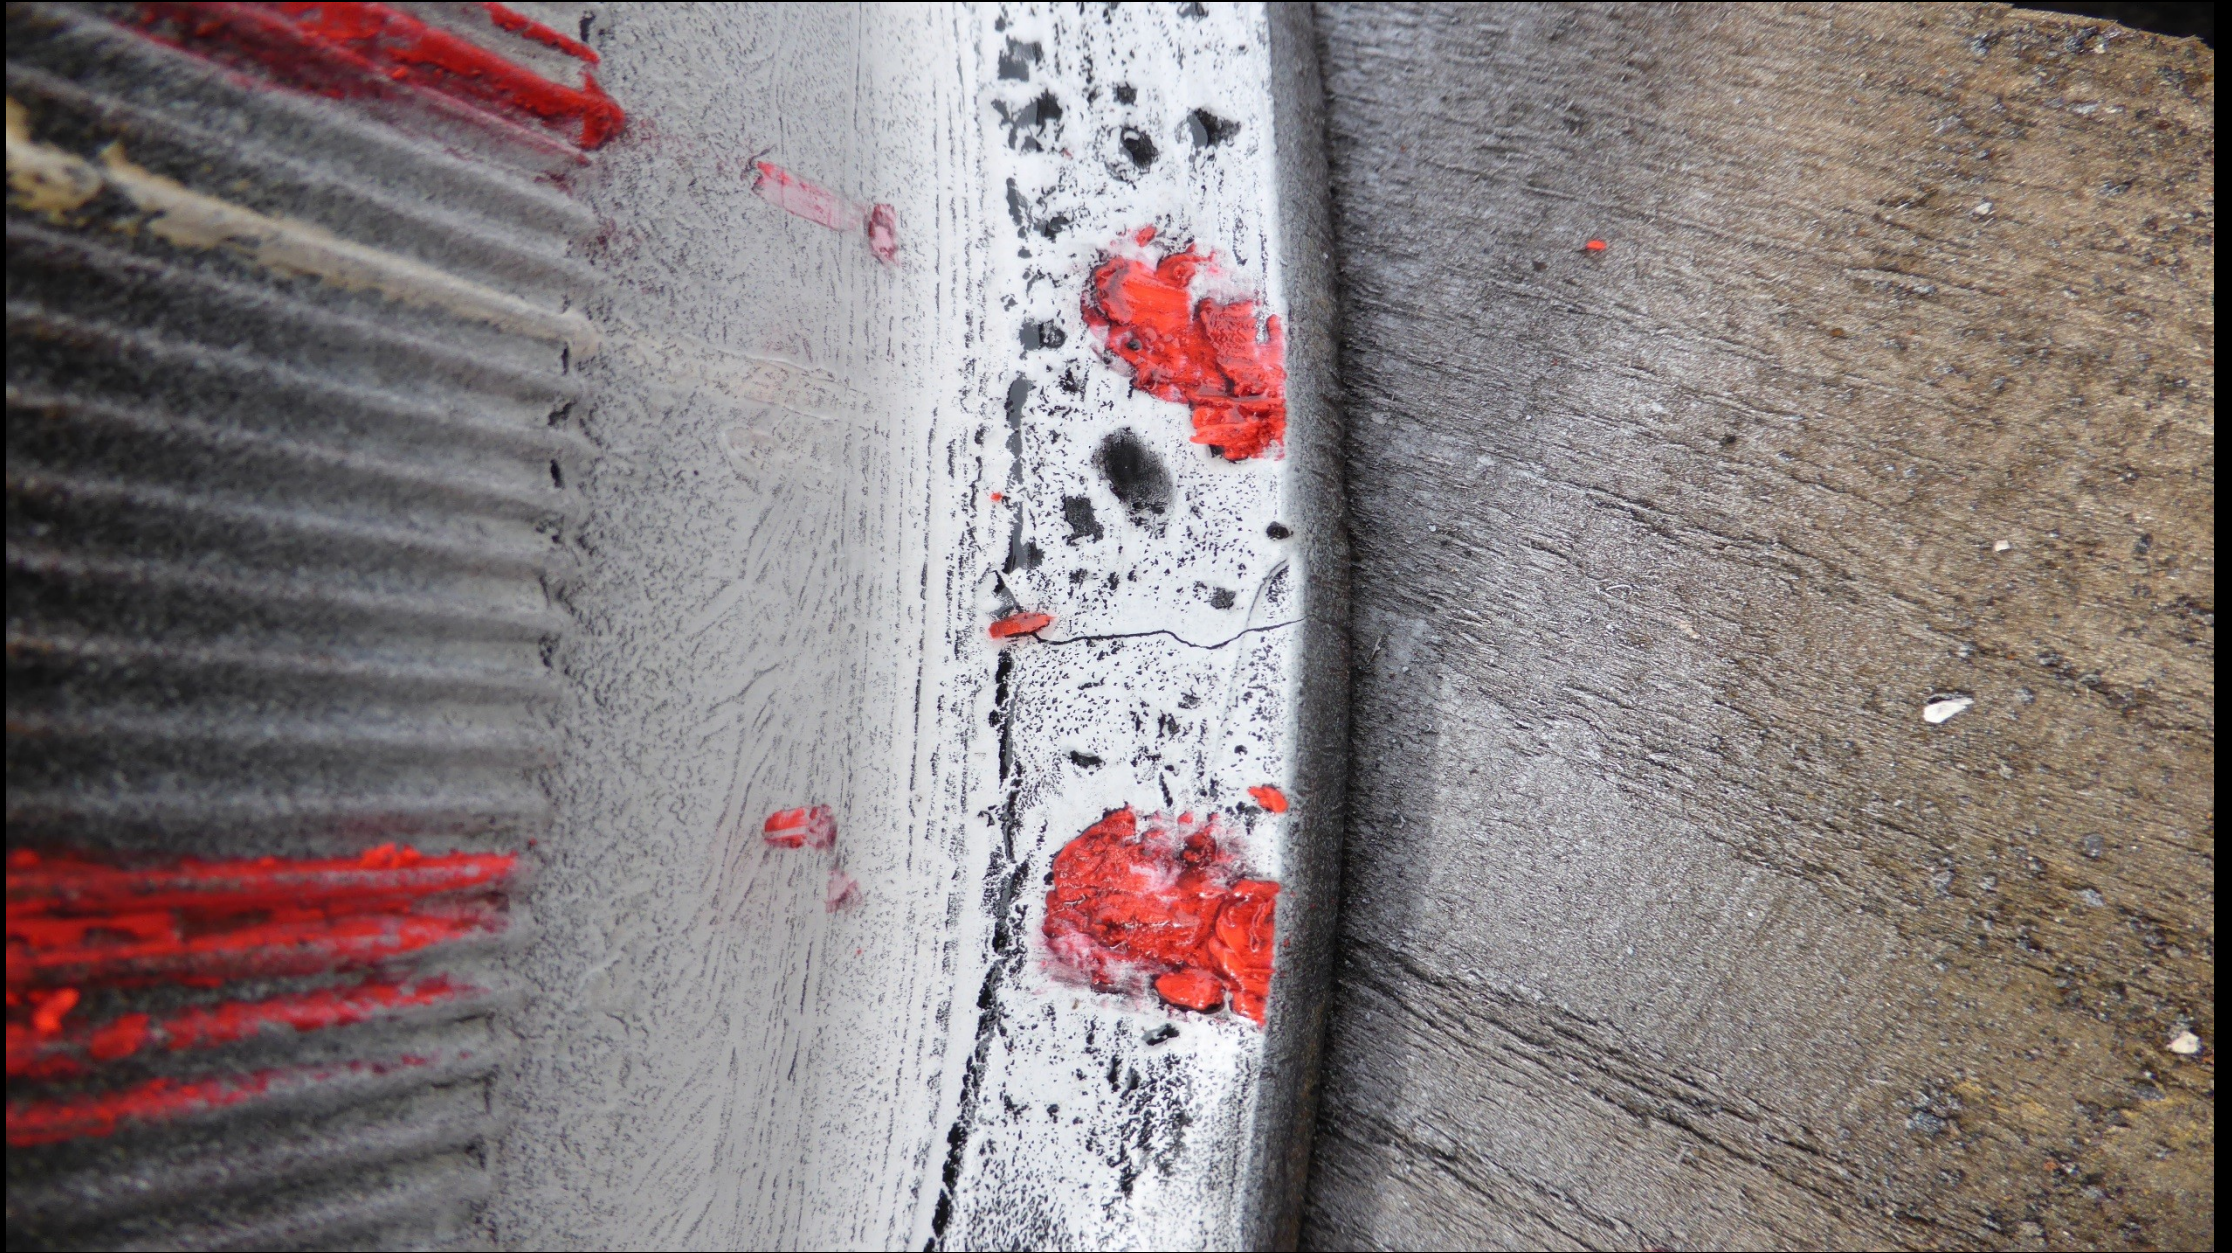
Figure 17: Crack in lip of Standard Back section
